SAFETY ALERT

07-S-10

LOG SPILL AT UNBINDING STATION

August 2007

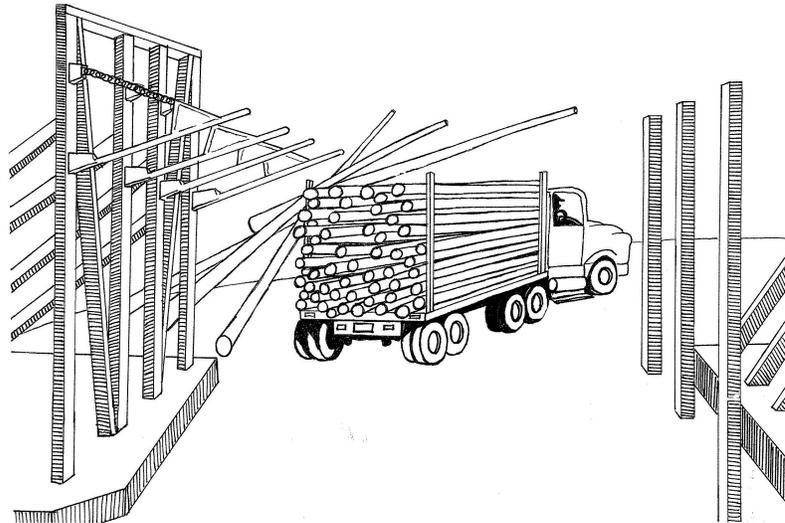
UNSAFE ACT OR CONDITION: The loader operator at the harvesting site loaded the stems above the trailer's standards. The truck driver had failed to recognize the height of the stems on the trailer and have the load corrected.

ACCIDENT: As the truck driver proceeded to the cranes to be unloaded after unbinding the load, several stems of pulpwood fell from the trailer. Apparently either the movement of the truck or the bumping of the swing arms of the unbinding station against the standards was all the force needed to make the stems fall from the trailer.

RECOMMENDATIONS FOR CORRECTION: Stems should never be loaded above the standards of a trailer. Drivers should carefully inspect loads before departing for delivery points. If stems are loaded above the standards, drivers (or anyone on the logging site) should instruct the loader operator to remove stems from the load.

All unloading facilities should be equipped with an unbinding station, and truck drivers must be required to use it. In this case, if the wood had fallen during unbinding, the unbinding station would most likely have caught the falling stems. However, if the driver had unbound the load outside of the station, or if a station had not been provided, a serious or fatal injury could have occurred.
