HAND INJURY- SPRAIN/STRAIN- DURING CLEAN UP

SAFETY ALERT • OCTOBER 2023

23-S-11

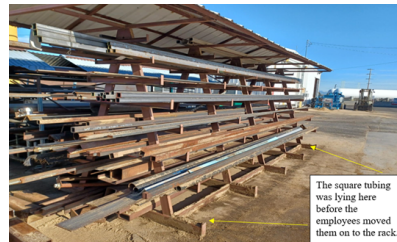
The square tubing was lying here before the employees moved them on to the rack.

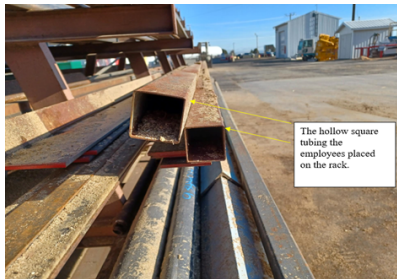
The hollow square tubing the employees placed on the rack.

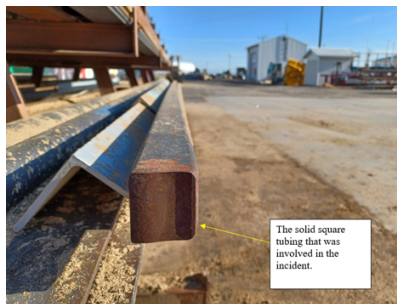
Conditions that contributed to this injury were the excessive weight of the square tubing on the rack. The employees were responsible for initially placing two hollow 20-foot tubes on the rack. Once that was complete, the employees attempted to place a solid 20-foot 2"x2" solid core tube on the rack, which was significantly heavier than the initial tubing. The employees were also working in inclement weather, including rain and cold temperatures, which could cause them to hurry and not take into account the differences in weight between the materials being handled.

One of the unsafe acts that led to this event was the failure to use a lifting device to handle the material properly. Company Policy states that personnel cannot lift more than 50 pounds manually, and each square tubing (hollow and solid) was above the 50-pound lifting limit. Employees are also required to complete a pre-task assessment for the project but, in this case, failed to do so.

The solid square tubing that was involved in the incident.

This is a prime example of where a pre-task hazard assessment could have prevented the injury. A forklift was available and located less than thirty yards from where the incident occurred, and both employees were trained and certified to operate a forklift.
