DISTRACTED LOG TRUCK DRIVER DIES AFTER TREE-LENGTH LOAD CRUSHES CAB DURING ROLLOVER

SAFETY ALERT • MARCH 2022

22-S-04

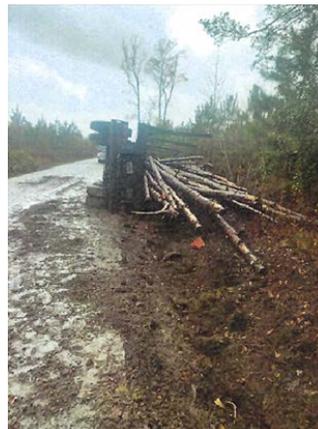
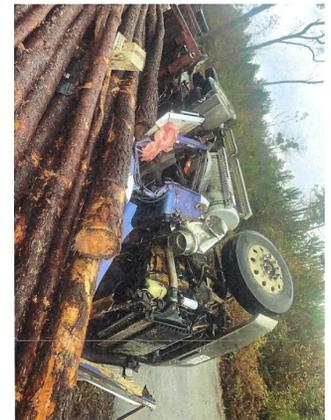
The logging business owner indicated that the driver secured the load with binding straps prior to entering the roadway. Both a driver-facing and forward-facing dash cam were installed in the cab. Video footage confirmed that the driver was traveling 35 mph at the time of the accident and was not wearing a seatbelt. After traveling approximately 1.5 miles from the logging deck, the dash cam footage shows the driver beginning to cough and reaching up to adjust the heat settings inside the cab. When the driver took their right hand off the steering wheel to reach for the temperature control settings, the truck drifted to the right and traveled off the paved road and into the ditch. There was no shoulder present on this section of the road, and there was a 3-inch drop off from the pavement to the ditch. The ditch was soft and slightly muddy from the rain that had fallen earlier in the day. As the truck left the road and entered the ditch, it overturned onto the passenger side. While overturning, the tree-length pine load continued to travel forward, pushing the aluminum headache rack into the rear of the cab.

The driver was crushed between the seat and the steering wheel. A passing motorist called EMS and then stopped by the logging deck to notify the crew of an accident a short distance away. When the crew arrived at the accident scene, they discovered that emergency responders were working to extract the driver. The driver was initially alert and communicating with emergency personnel. It took approximately 30 minutes to extract the driver from the wreckage. The driver remained conscious for about 20 minutes of the extraction period but was unresponsive when pulled from the overturned truck. After immediately attempting CPR, the driver was pronounced dead at the scene. After cleaning up the pulpwood post-accident and delivering it to the mill it was determined that the load was within legal weight limits. Inspections were current for both the cab and trailer. It was also determined after the accident that the binding devices used were the hand-ratcheting type and hooked onto the trailer, not the trailer-mounted binding system designed to properly secure the load.

- Heavy-duty steel headache racks should be mounted directly onto the trailer to keep shifting loads from gaining momentum and becoming projectiles during an accident
- Always use an appropriate load binding system designed to safely secure a load during transport
