Collision with Train Injures Log Truck Driver

SAFETY ALERT • OCTOBER 2022

22-S-10

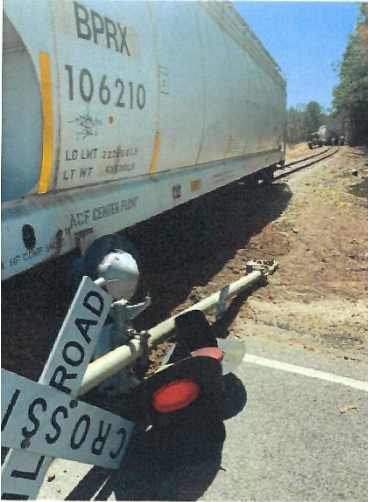
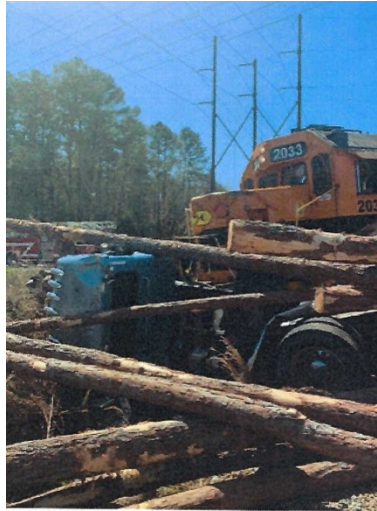
INCIDENT IMAGES

When the business owner arrived at the accident scene, EMS had already started transporting the injured truck driver and locomotive engineer to a regional medical center by ambulance. The truck cab was crushed, but the driver was protected by the heavy-duty headache rack, which prevented logs from penetrating the cab. The driver was admitted to the ICU and diagnosed with four shattered ribs and a liver laceration. He was released from the hospital two days later for an 8-week in-home recovery period. Drug and alcohol screening was negative.

- The driver failed to yield the right of way to oncoming train by disregarding the flashing warning signal.
- The driver was operating a moving vehicle while distracted and not paying attention to his surroundings.

- Always be aware of your surroundings and avoid any distractions while driving.
- Use "Do Not Disturb" mode or a similar safety feature on smartphones to eliminate the temptation to answer calls or texts while driving.
- Stop a safe distance away from the tracks at railroad crossings to ensure the tracks are clear of oncoming trains.
