# Driver Injured While Failing to Maintain a Safe Following Distance

**SAFETY ALERT • DECEMBER 2022**

**22-S-16**

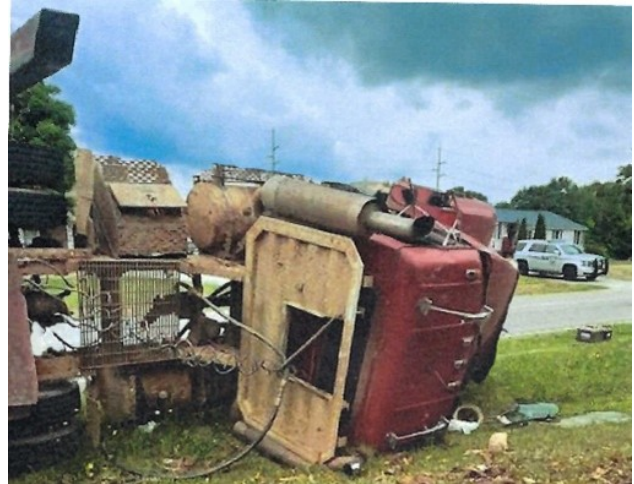
The driver was traveling on a secondary state highway and was following a sedan vehicle. For no apparent reason, the vehicle began to drive erratically and suddenly decided to make an abrupt left-hand turn. The log truck driver was following too close to the sedan and did not have enough time to stop and avoid a rear-end collision with the car. Therefore, the driver elected to steer his truck and trailer to the right and onto the shoulder to avoid striking the car. The driver was able to avoid a collision with the vehicle; however, his trailer traveled into a ditch, flipping the entire truck and trailer onto the passenger side and spilling the load of roundwood. The driver was wearing his seatbelt. An interview with the business owner revealed that he had already purchased a dash camera system but had yet to install it.

The driver was traveling too close to the sedan which prohibited him from being able to stop in time to avoid a collision.

- Always maintain a safe following distance
- Be aware of posted speed limits and, if necessary, reduce speed
- Dash camera installation should be a top priority
