Log Truck Driver Injured During Crash While Not Wearing a Seatbelt

SAFETY ALERT • DECEMBER 2022

22-S-17

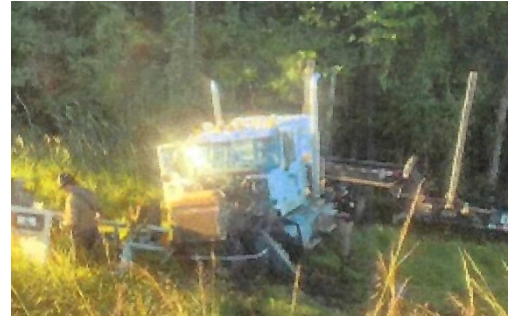
County rescue workers found the driver lying on the passenger floorboard of the cab. He had sustained injuries to his right leg in addition to head lacerations. The driver was extracted from the cab around the time additional EMS personnel arrived on the scene. The driver was transported to a local medical center for further evaluation and treatment. While shaken from the accident, the driver did not sustain any serious injuries.

The driver was not able to communicate with first responders and did not indicate a cause for the accident. He later claimed that he ran off the road to avoid hitting a deer and lost control of the truck and trailer. A post-accident inspection revealed that the driver was not wearing his seatbelt. The cab did not have a dash camera system installed.

- Always wear a seatbelt while traveling in a moving vehicle.
- Keep tires on the pavement at all times to maintain proper control.
- Always stay alert and focused on driving.
- Consider requiring all employees to sign a “safety rules document” to ensure understanding of company safety policies and rules compliance.
- Be vigilant when deer are active, especially at night and during hunting seasons.
- Consider dash camera installation on all trucks.
