# Motor Grader Operator Injured While Replacing Cutting Blades

**SAFETY ALERT • JULY 2023**

**23-S-06**

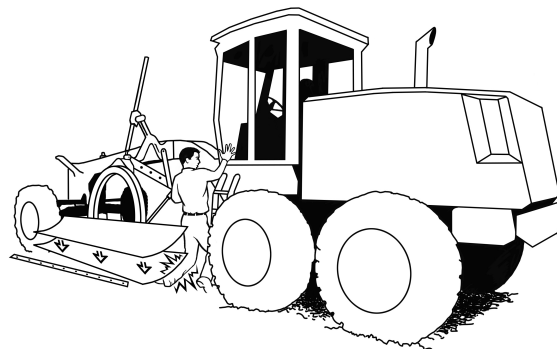
The operator did not de-energize the machine and relied on the equipment's hydraulic system to keep the table and moldboard in place. The operator also placed himself in a dangerous position by stepping between the moldboard and the cab while performing maintenance on the motor grader.

The operator began by disengaging the link pin to move the moldboard into position and then attempted to re-engage the link pin before starting his routine maintenance. He then shook the moldboard with the hydraulic system to ensure the link pin was engaged. The moldboard was then positioned at the side of the grader to begin the blade removal process. The blades were removed without incident, and the operator began cleaning the moldboard before installing the new blades. Next, the operator stepped around the moldboard to get a wire brush from the cab, placing himself between the moldboard and the grader cab. Suddenly, the table and moldboard fell, striking the operator in the back of his leg. The operator was able to call his supervisor for help, and EMT personnel were dispatched to the accident scene. The injured operator was transported to a local hospital for further evaluation and treatment. A post-accident inspection revealed that the link pin was not properly engaged, and a proper zero-energy process was not employed.

- Always be aware of your surroundings and never place yourself in a position to be injured by stored energy during routine equipment maintenance and servicing.
- Develop lock out/tag out procedures to de-energize equipment to a zero-energy state during equipment maintenance and repair.
